September 11, 2023

**REPORT OF BINATIONAL JOINT SURVEY  
OF AUGUST 30, 2023, OF THE  
BUOYS INSTALLED  
WITHIN THE RIO GRANDE  
NEAR EAGLE PASS/PIEDRAS NEGRAS**

**Maverick County, Texas**

**INTERNATIONAL BOUNDARY & WATER COMMISSION  
United States Section  
El Paso, Texas**

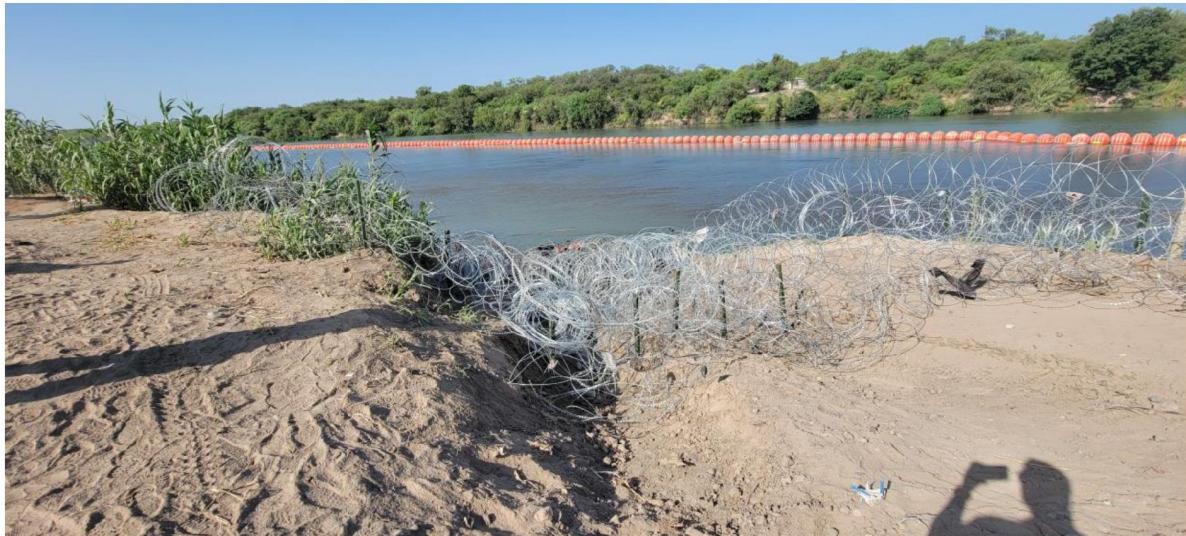
**Exhibit 2: View of the Eagle Pass Buoys**

The State of Texas installed a buoy barrier in the Eagle Pass/Piedras Negras reach of the Rio Grande in early July (**Exhibit 1**, **Exhibit 2**). The location of the buoys is approximately 2 miles (3.2 kilometers) downstream of the Camino Real International Bridge, in the vicinity of 28° 40' 21" N, 100° 30' 14" W. The State of Texas installed the buoy barrier in this area for the purported purpose of deterring the passage of migrants who cross the border at this location in large numbers by swimming/walking across the river. The four-foot diameter buoys are anchored to the ground by concrete blocks. They also have webbing below them that prevents people from swimming under the buoys.

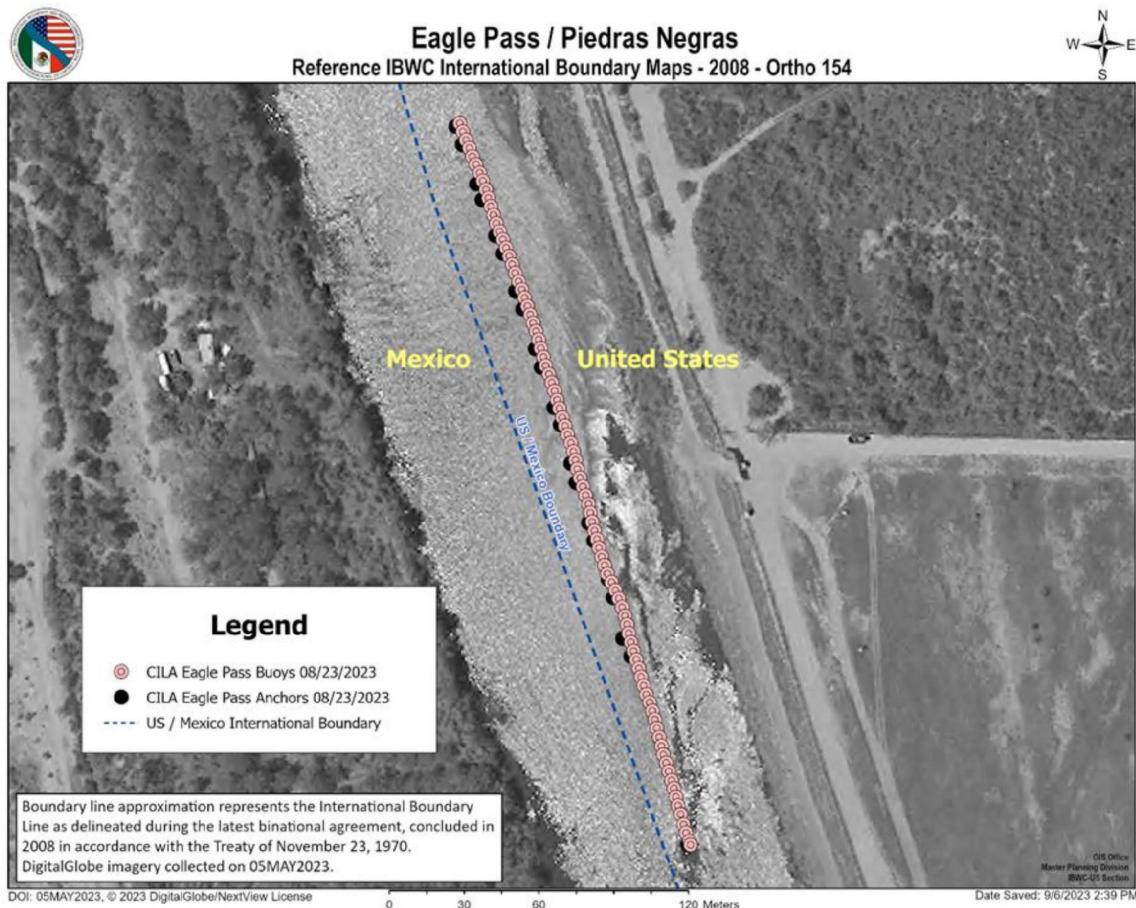
**Exhibit 3: Survey Data Plot of the IBL and Eagle Pass Buoys  
(Mexican Section Survey of August 23, 2023)**

The Mexican Section conducted another survey on August 23, 2023, to verify if this new buoy alignment encroaches into the territory of Mexico. The survey used a horizontal datum of World Geodetic System (WGS) 1984 Universal Transverse Mercator (UTM) Zone 14 N coordinate system. Results of the Mexican Section survey showed that the realigned buoys are now entirely within the U.S. side of the IBL (**Exhibit 3**).

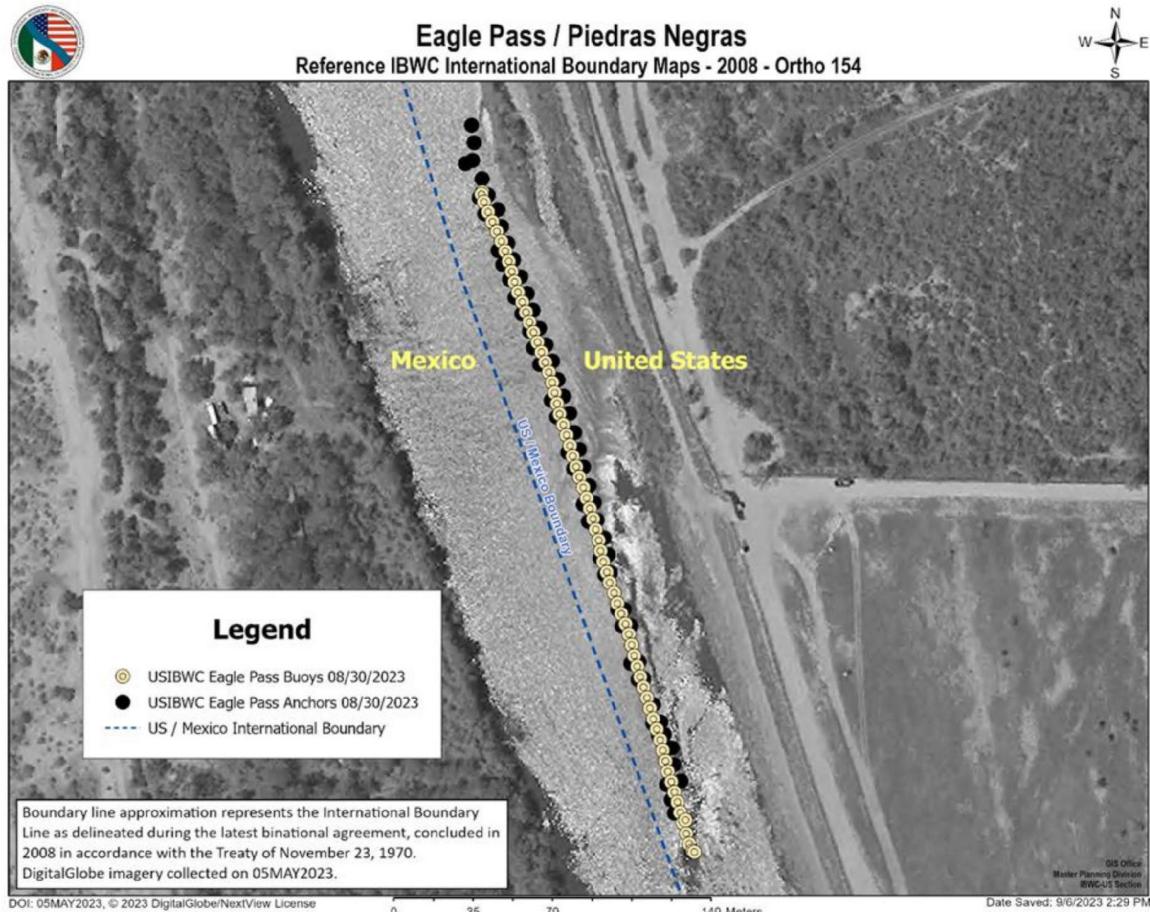
**Exhibit 4: Survey Data Plot of the IBL and Eagle Pass Buoys  
(IBWC Binational Joint Survey of August 30, 2023)**

The survey data indicated that the realigned buoy alignment is located entirely on the U.S. side of the IBL (**Exhibit 4**). The results of the binational joint survey are consistent with the findings of the Mexican Section survey of August 23, 2023.
